# Ecobeach

Investigations for a natural stabilization of the coast

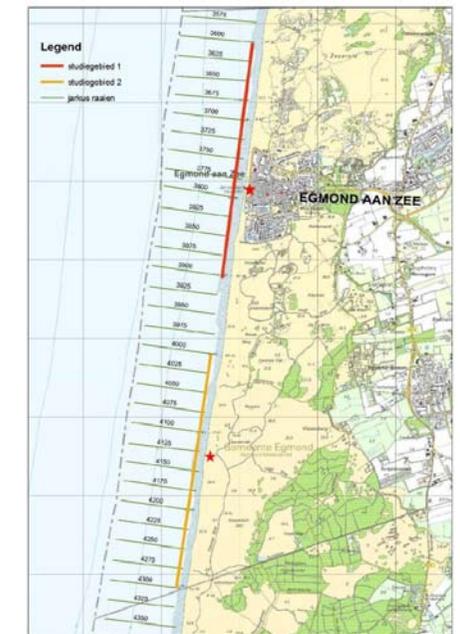
The second test area for Ecobeach (source: Deltares)

Ecobeach was tested at two locations of three kilometres length each. The northern test area is located near Egmond aan Zee between kilometre 36 and 39. The southern test site is located between Egmond aan Zee and Castricum aan Zee between kilometre 40 and 43. The reference area – also 3 kilometres in length, but without drainage tubes – is located directly south of this.

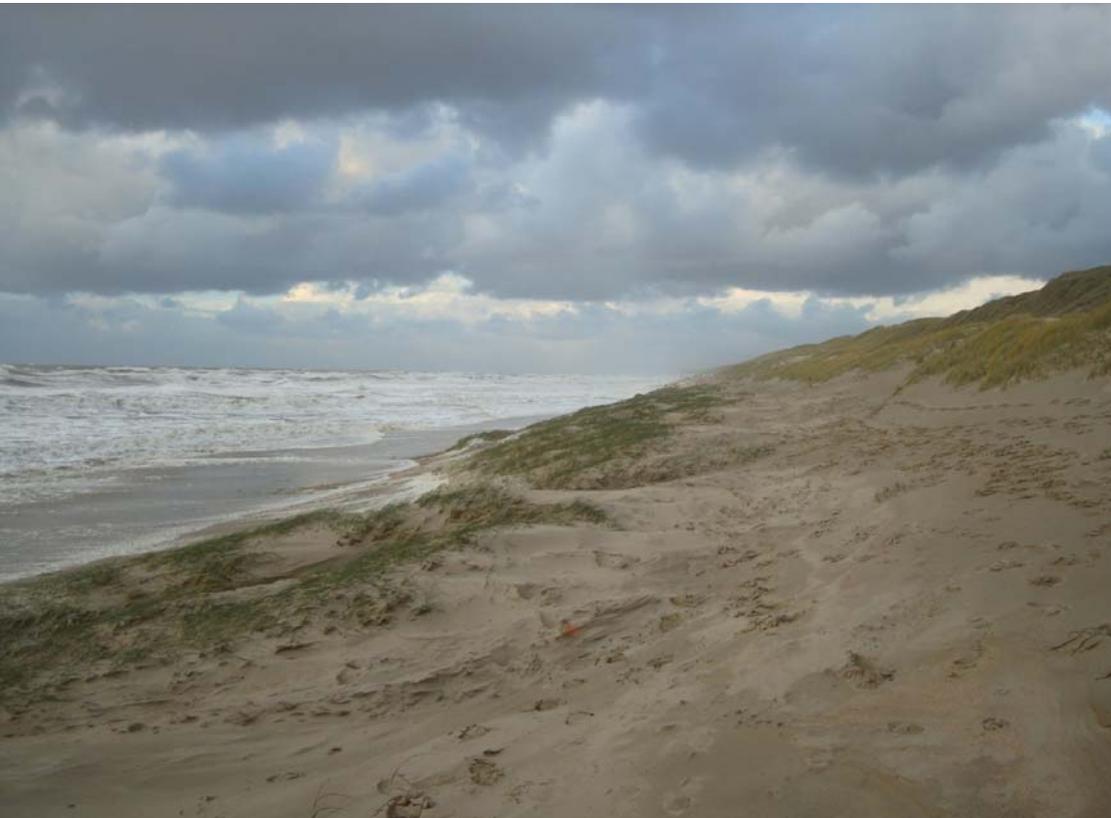
During the tests, the following observations were made:

- At the beach in the southern test area, circa 115,000 m<sup>3</sup> of sand accumulated – measured over a length of 2750 meters of beach – during the project (2007 – 2010).
- The beach became wider.
- The beach in the reference area also grew.
- Sand transport took place and the dunes grew.
- 2.5 years after the beginning of the tests, the sand in the southern test area was 30 % coarser than in the neighboring areas. The median grain size was approximately 400  $\mu$  and the coarser sand was located in the top 2 m.
- Due to the digging during the removal of the tubes locally quicksand occurred.
- An interesting observation: After the tests and after removal of the tubes, the beach volume decreased in both the test and reference areas.

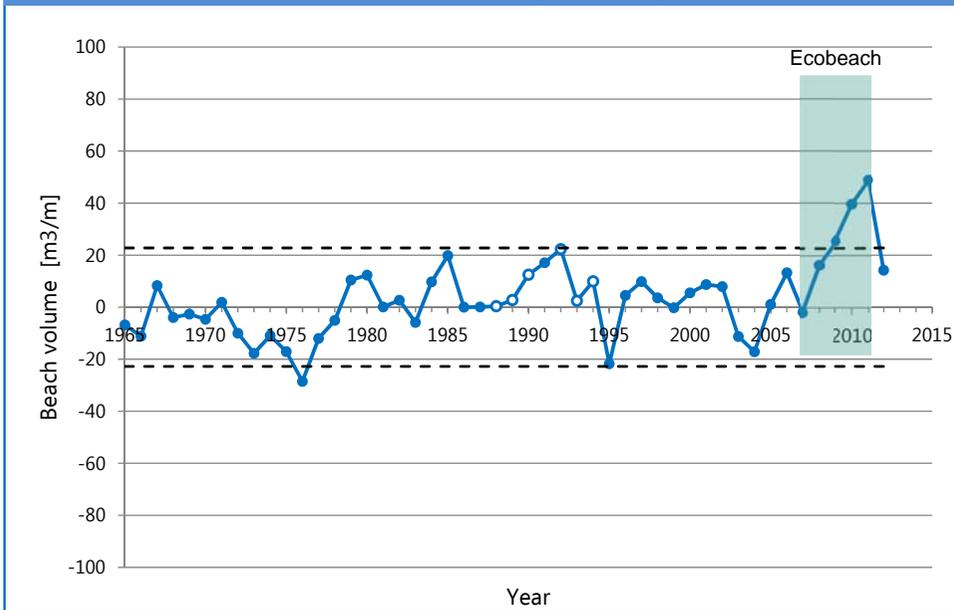
Beach volume in the test area south, 3 km average, with respect to fixed reference line

The dotted line show the 95 % confidence interval for the 1965 – 2006 data

In 2007 the drainage tubes were installed 25 cm below the beach surface. When they were removed at the end of the test period, some of them were located more than 1.50 m below the sand. During the test period from 2007 to 2010 the beach at the southern test area grew by about 50 m<sup>3</sup> per meter of beach. The beach volume, both in the test area as well as in the reference area, was significantly larger than predicted based on the available data from the previous years. After the tests and after the removal of the tubes, the beach volume decreased in both areas.

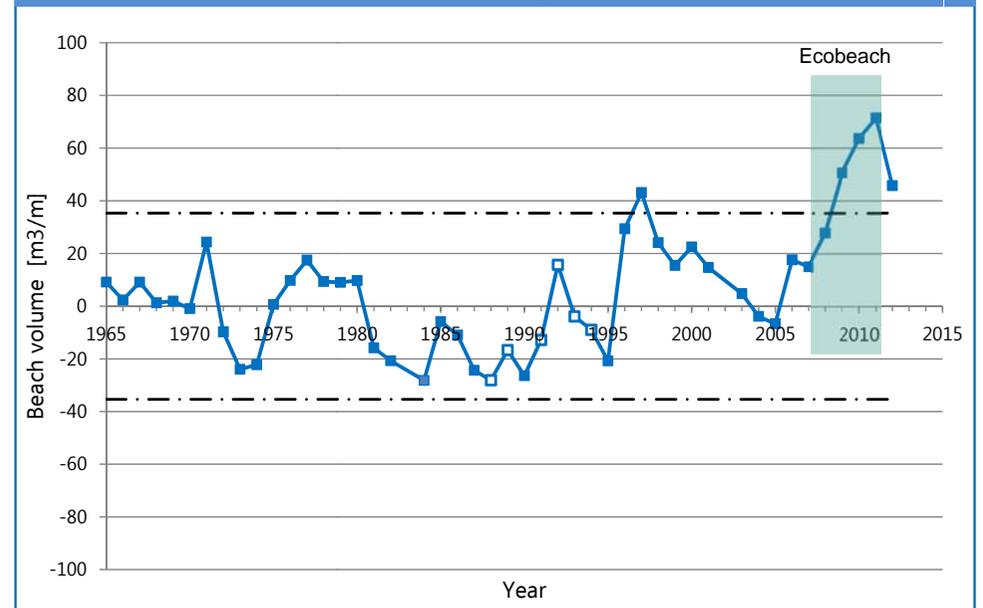
Beach volume at the reference site, 3 km average, with respect to fixed reference line

The dotted line show the 95 % confidence interval for the 1965 – 2006 data
