Ecobeach

Investigations for a natural stabilization of the coast

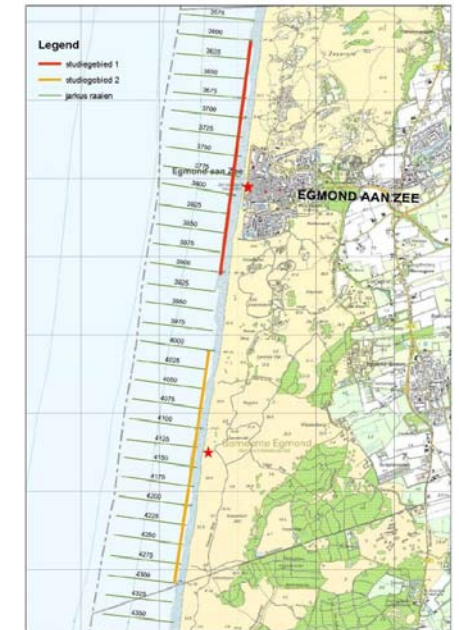
The two test areas for Ecobeach (source: Deltares)

Ecobeach was tested at two locations of three kilometres length each. The northern test area is located near Egmond aan Zee between kilometre 36 and 39. The southern test site is located between Egmond aan Zee and Castricum aan Zee between kilometre 40 and 43. The reference area – also 3 kilometres in length, but without drainage tubes – is located directly south of this.

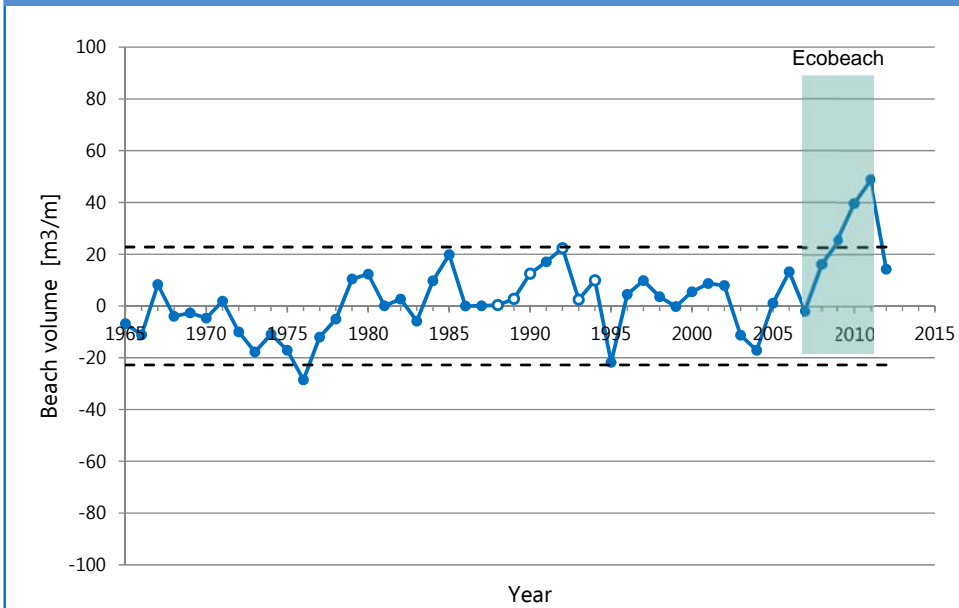
Beach volume in the test area south, 3 km average, with respect to fixed reference line

The dotted line show the 95 % confidence interval for the 1965 – 2006 data

In 2007 the drainage tubes were installed 25 cm below the beach surface. When they were removed at the end of the test period, some of them were located more than 1.50 m below the sand. During the test period from 2007 to 2010 the beach at the southern test area grew by about 50 m³ per meter of beach. The beach volume, both in the test area as well as in the reference area, was significantly larger than predicted based on the available data from the previous years. After the tests and after the removal of the tubes, the beach volume decreased in both areas.

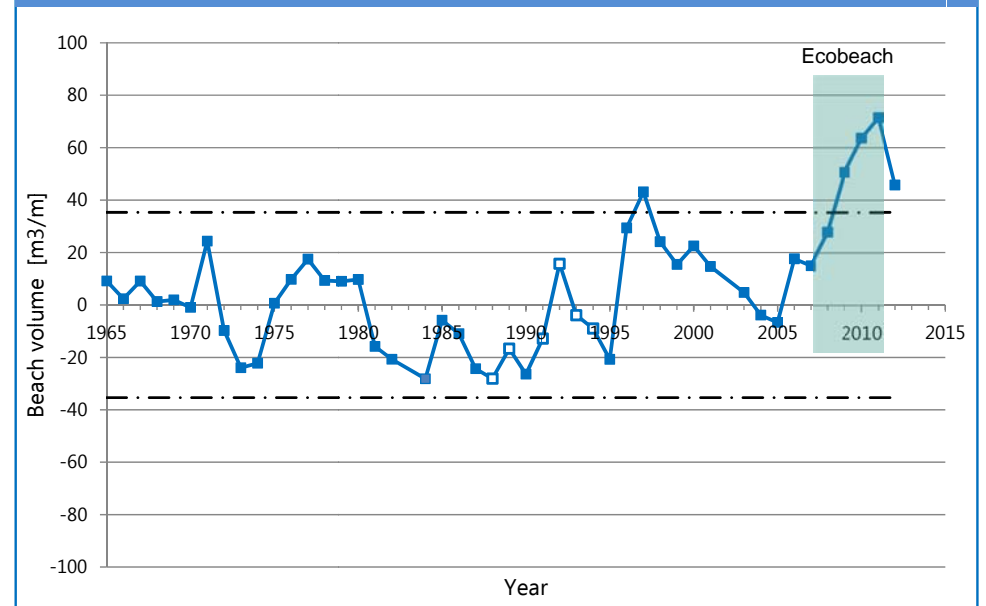
Beach volume at the reference site, 3 km average, with respect to fixed reference line

The dotted line show the 95 % confidence interval for the 1965 – 2006 data
